Back Analysis of Shear Strength Parameters of a Large Rock Slide in Sikkim Himalaya

Rajinder Bhasin^{1*}
Mahdi Shabanimashcool¹
R.L. Hermanns²
O.A. Morken²
J.F. Dehls²
Vikram Gupta³
Aniruddha Sengupta⁴

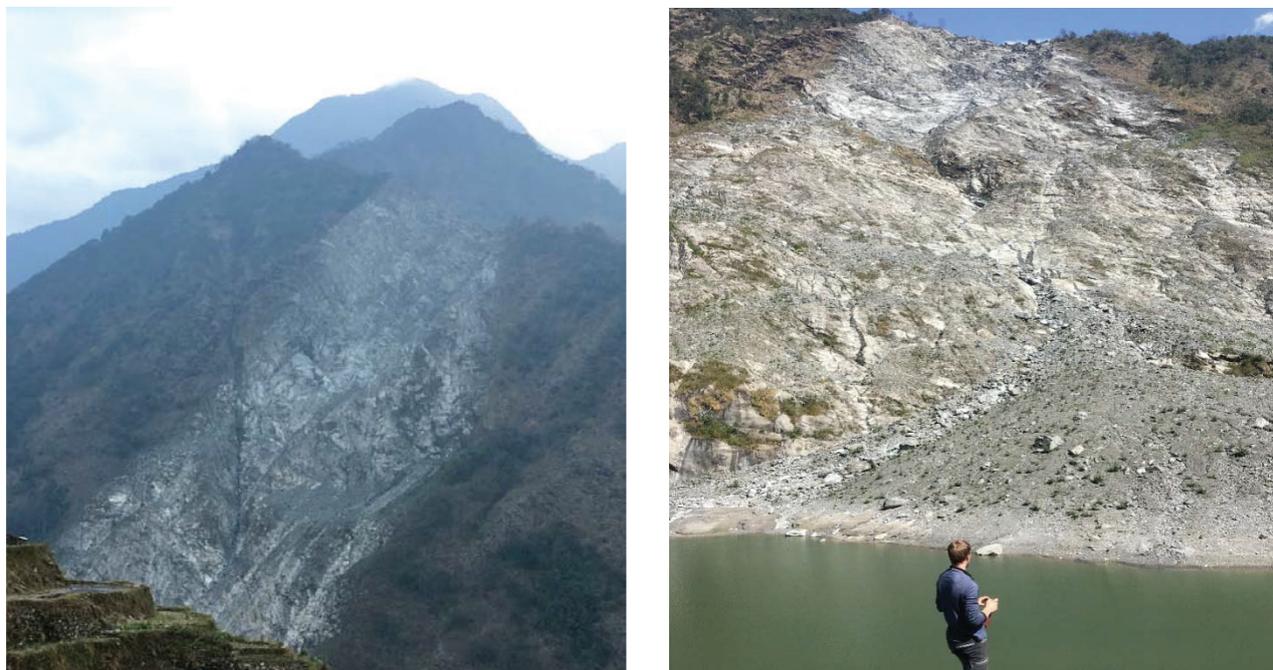
Under a joint research co-operation programme between India and Norway (INDNOR), landslide investigations were performed in Northern Sikkim where Dzongu landslide was investigated. This is a massive landslide which occurred near the village of Mangan around 13:30 h (IST) on 13 August 2016. Figure 6 shows the photos of the landslide taken from the top and from the bottom of the landslide which is basically in gneissic schistose rock. The landslide is around 900 m long and 500 m wide. Several million cubic meter material of the rock mass failed which blocked the river Kanaka and TholungChhu which are tributaries of the Teesta river. The lake washed away about 300 m stretch of the road and submerged five houses in Mangan village (Martha et al., 2017). According to eye witnesses the rock slide generated a huge cloud of dust due to its rapid downward movement resulting in an air-blast. The thickness of the debris varied between 30-50 m and the size of some of the boulders observed on the debris were about 50 cubic meters. The landslide was rectangular in shape as can be seen in Fig. 6. Three sets of joints dipping towards, East, West and North-East could be identified. The exposed landslide suggested a translational type of failure in the main body with the possibility of a wedge type failure on the top. As mentioned earlier this area suffered a severe earthquake in 2011 where several large landslides occurred on the upstream side and crack developments were evident in areas near the epicentre of the earthquake including the Dzongu slide area. Figure 7 shows a recent google image of the area in which one can see the Dzongu landslide that occurred in 2016 while another landslide called the Bay Tholung landslide on the upstream side occurred during the 2011 earthquake. The major cause of failure of the Dzongu landslide may be attributed to the ground water seepages in cracks over the years resulting in reduced shear strength of the rock mass.

Fig. 6 - Picture of the Dzongu landslide taken from the top (left) and from the bottom

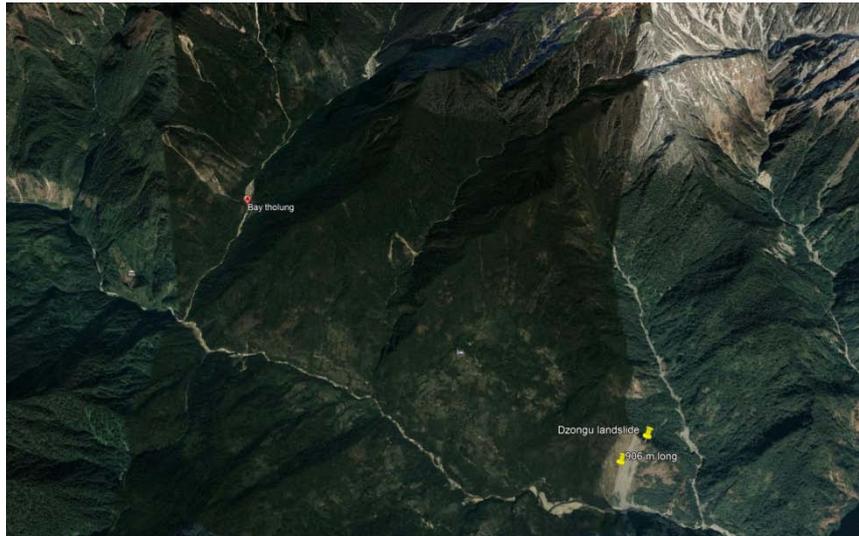
Fig. 7 - Google image of the Dzungu landslide that occurred in 2016 and the Bay tholung landslide which occurred during the 2011 earthquake

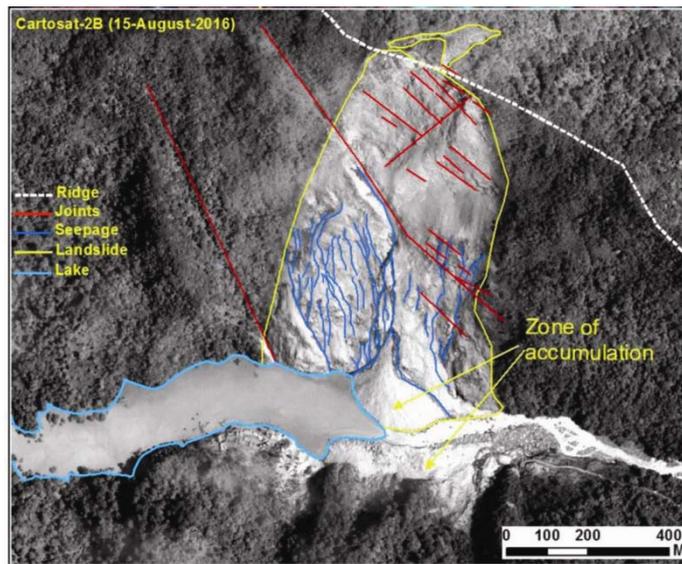
Ground water seepages from the exposed joint planes were identified through satellite images by Martha et al.(2017) (Fig. 8). A back-analysis of the joint shear strength parameters of this landslide is performed to gain a better understanding of the mechanics and behaviour of the landslide.

Fig. 8 - Cartosat image of Dzungu landslide showing the water seepage through joints after its failure (Martha et al., 2017)

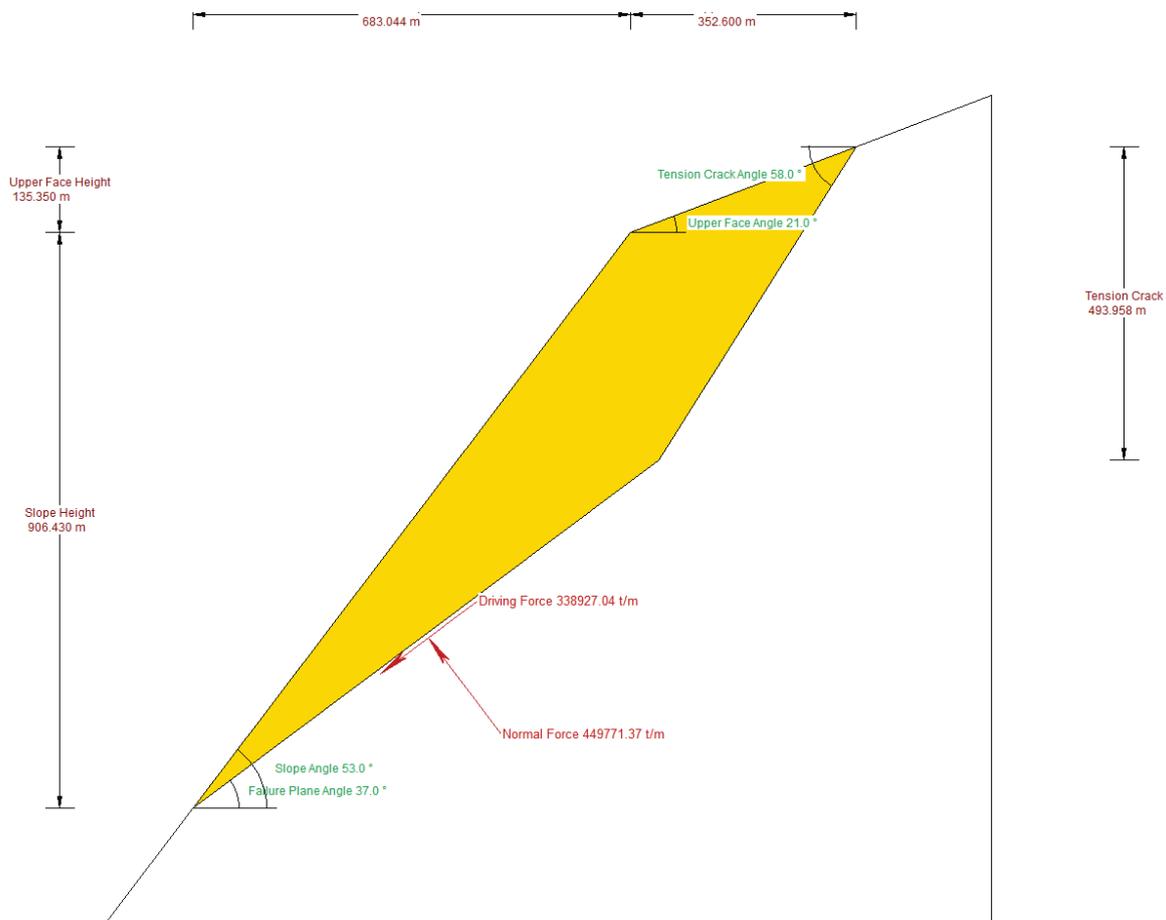
Fig. 9 - Block model used for the analysis of the landslide in RocPlane software

Applying the joint strength input parameters (JRC=10, JCS=150 MPa, $\Phi_r=26^\circ$) to the model shown in Figure 9 the factor of safety was computed as 1.22. This factor of safety was calculated based on the assumption that there exists no pore water pressure and seismicity.

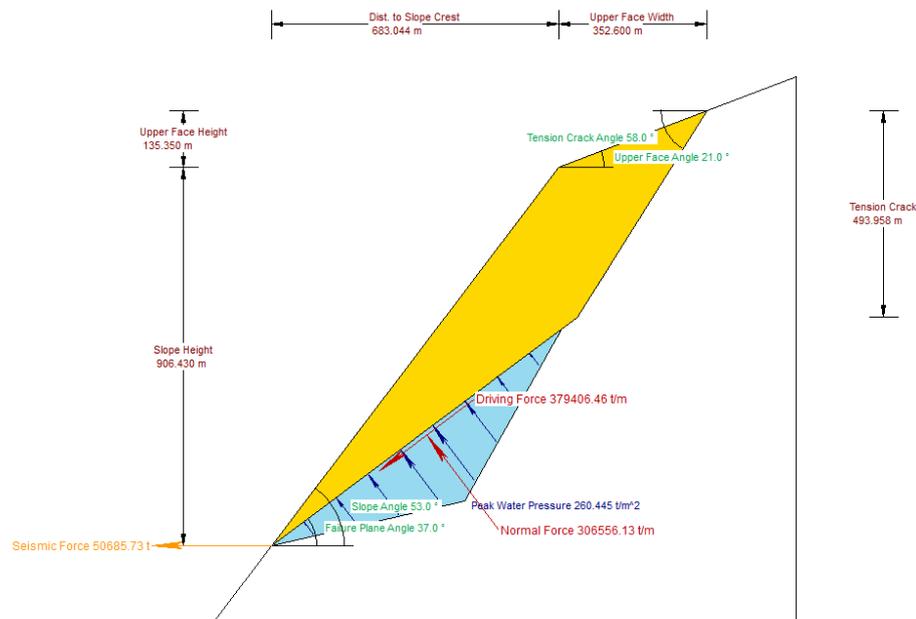
In the next phase of analysis water pressure was included by applying peak pressure in the middle of the slope and 20% water filled relative to the height of the slope. This situation would probably have occurred over a period of time as the water started seeping into the joints as explained earlier. In this case the factor of safety was reduced from 1.22 to 1.17. It was noted that as soon as the water was filled up to 50% of the height of the slope in the model the factor of safety become less than 1.0 indicating that water has a major influence on the stability of the slope. Figure 10 shows the case when the water was filled to 50%.

Fig. 10 - Block model with pore water pressure in the landslide

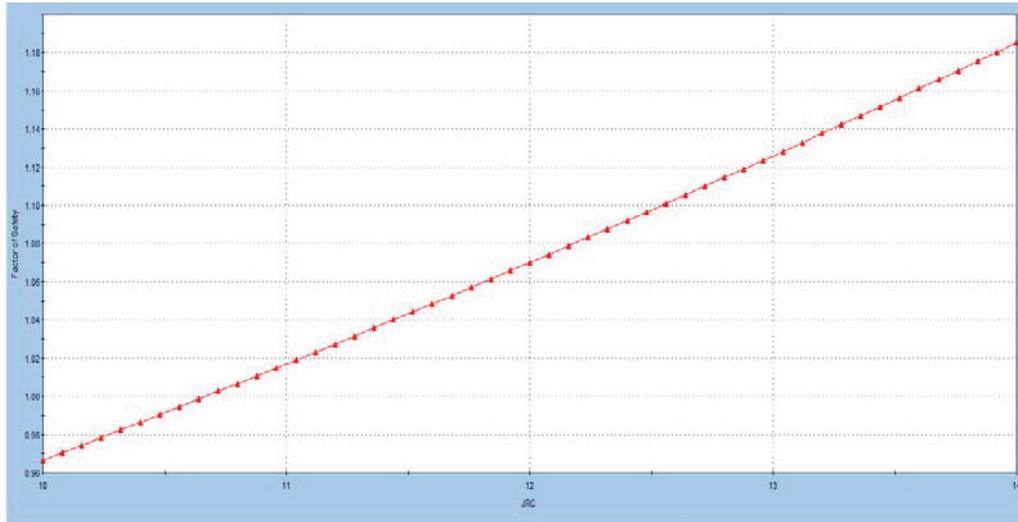
Fig. 11 - Joint roughness coefficient (JRC) versus factor of safety (FOS), below JRC 11 the slope becomes unstable

In the next phase of simulation seismic loading was considered. To simulate earthquake loading, we need to know the seismic coefficient which is a dimensionless number that defines the seismic acceleration as a fraction of the acceleration due to gravity. Typically, the coefficient might be around 0.1-0.2. In the analysis, a relatively small earthquake loading using a seismic coefficient of 0.1 is applied to the model without any water pressure (dry slope). The results showed that the factor of safety was reduced from 1.22 to 1.0 indicating that a small amount of water is required to destabilize the slope. According to the hazard zonation map of the area the seismic coefficient should actually be in the range of 0.3-0.4. These relatively high seismic coefficients were obtained through large scale seismicity analysis for seismic source zone classification and estimation of maximum credible earthquake for a deterministic or quasi-probabilistic seismic scenario generation (Pal et al, 2000). In the analysis, if the seismic coefficient is increased to 0.3 the slope fails immediately signifying the fact the slope was highly vulnerable to earthquake loading. Several sensitivity studies have been performed on the slope by changing the shear strength parameters and by varying the water pressure etc. One interesting result indicated that if the shear strength JRC is increased from 10 to 12 then the slope is still stable with a FOS of 1.07 even though we have water pressure (20%) and seismic coefficient of 0.1. This result is shown in Figure 11 where JRC is plotted on the horizontal axis and FOS on the vertical.
