Numerical Study of a Failure of a Reinforced Earth Retaining Wall

A. Sengupta

Abstract The case history of a failure of a RE wall has been presented. The wall failed immediately upon completion due to the overestimation of the strengths of the foundation clay layers and due to the underestimation of the self weight of the fill materials. A typical cross-section of the wall along with the stabilizing embankment and the foundation are modeled numerically by the limit equilibrium method and by a finite element method. The strengths of the foundation soils are determined by field tests done after the failure of the wall. Both the analyses predicted failure of the wall. The deformations predicted by the finite element method are found to be comparable to the observed field data. The numerical analyses further indicate that by consolidating a foundation clay layer to a minimum undrained strength of 45 kPa, the required factor of safety for the wall along with the road embankment can be achieved theoretically. Accordingly, prefabricated vertical drains are used to expedite the drainage and consolidation of the foundation clay layers. After the field tests confirm that the required minim

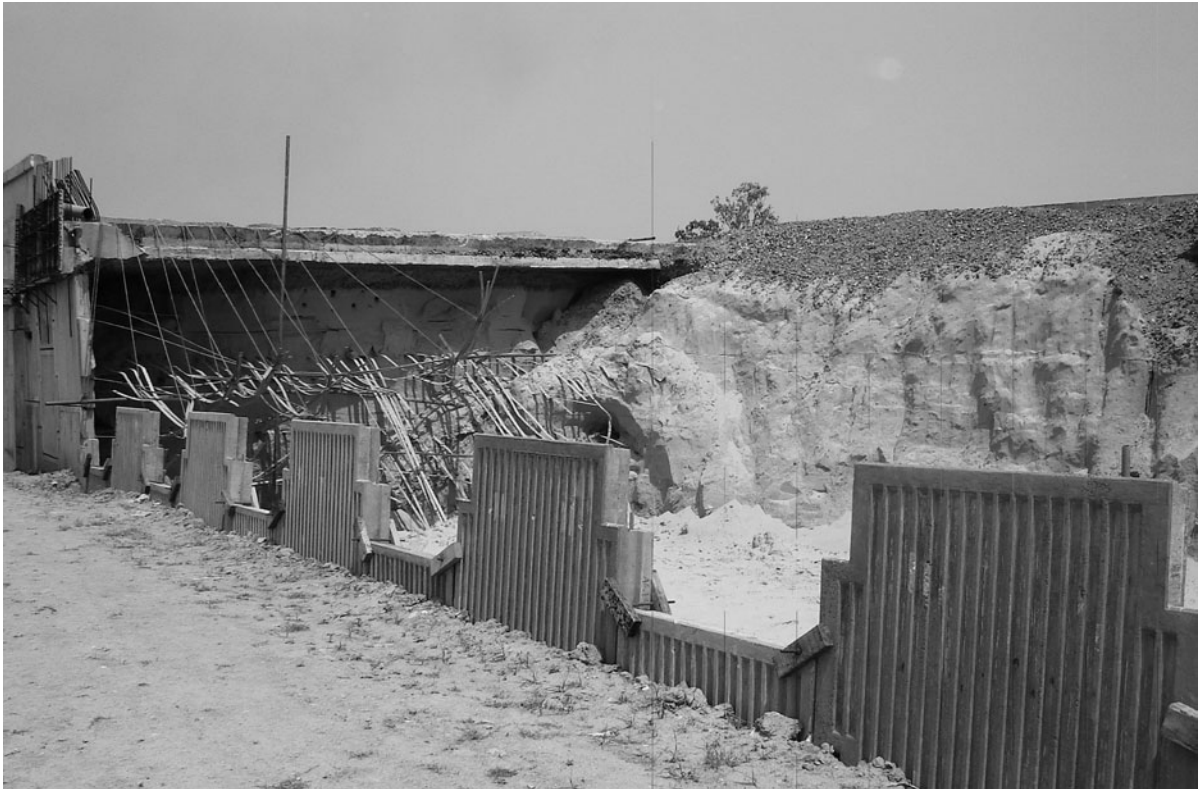
A reinforced earth (RE) retaining wall supporting a 10.7-m high earthwork adjacent to a highway bridge on National Highway, NH-6 near Kolkata (India) developed a distress on the early morning of February 9, 2006. The affected bridge approach was opened to traffic about a month prior to the date of the incident. During this incident, a section of the newly constructed 4-lane approach vertically settled rapidly by about 3 m and laterally translated outwardly by about 1 m (see Fig. 1). The subsidence covered a width of about 60 % of the newly constructed bridge approach. Though the movement was relatively rapid initially, post failure records indicate that the structure continued to move for 9 days following the initial failure as is apparent from Fig. 2.

Fig. 1 Failure of the RE wall (note the exposed portion of the concrete bridge and the remains of the RE wall)

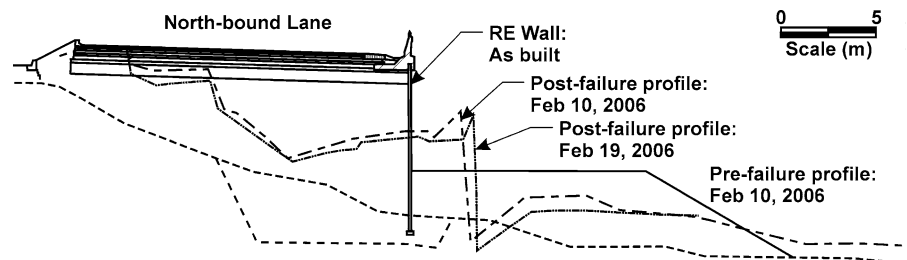
Fig. 2 Failed embankment cross section prior to and following the incident

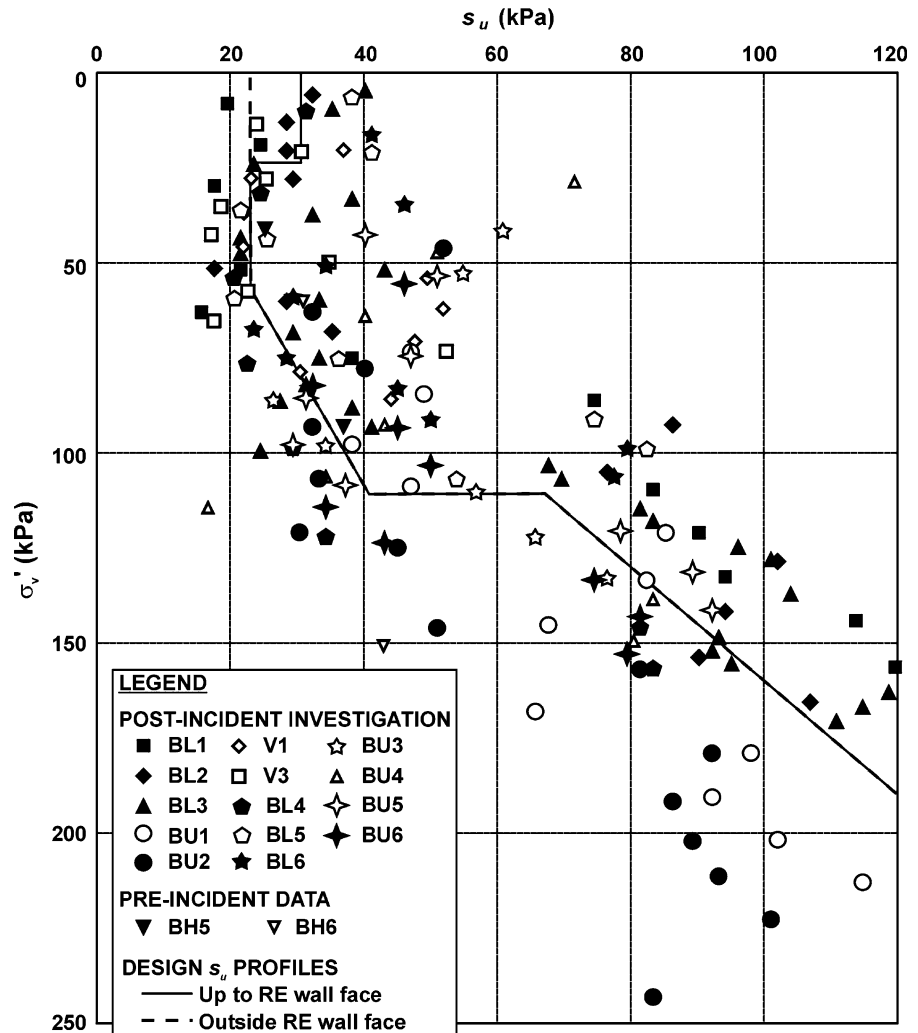
have been obtained from investigations conducted within or near the affected section of the embankment before the construction of the RE wall. Only two boreholes, BH5 and BH6, were drilled near the site prior to the construction of the RE wall. Four estimates of undrained shear strength obtained from the laboratory testing of samples extracted from these boreholes are of any relevance. These data, included in Fig. 4 for

Fig. 4 Measured undrained shear strengths

comparison, do not appear to capture the soft nature of the near surface soils outside the toe of the RE wall.

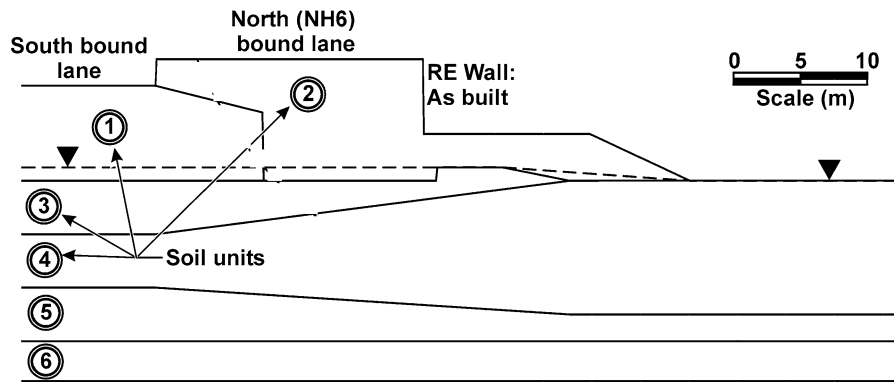
Figure 5 shows a typical cross section of the road embankment along with the foundation soil profiles at the failed section of the highway. The strength parameters of the different soil types shown in the figure are presented in Table 1.

Fig. 5 A typical pre-failure RE wall cross section

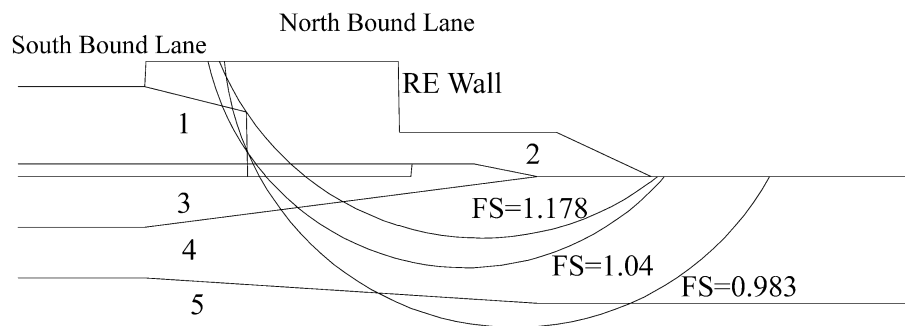
Using the shear strength parameters listed in Table 1, undrained stability of the RE wall is assessed for the RE wall configuration (refer to Fig. 5) at the time of the incident. A modified version of the limit equilibrium slope stability assessment computer program UTEXAS2 (Edris and Wright 1992) is used in this analysis. For computing the minimum factor of safety, the simplified Bishop method of analysis (Bishop 1955) was adopted. In the simplified Bishop's method, the interslice forces are assumed to be horizontal. The force equilibriums in both directions are not satisfied but the overall moment equilibrium is satisfied. A search is performed for a critical circular slip surface and the corresponding limit equilibrium factor of safety, FS . The results are presented in Fig. 6. These results indicate that the wall was indeed in a state of marginal stability.

The present limit equilibrium stability assessment indicates that the original RE wall would have been at a state of instability with a static factor of safety of 0.983 at the time of failure. The original design indicated a limit equilibrium factor of safety against

bottom rotational failure under static condition of 1.42. Major reasons for the lack of agreement between the present analyses and those carried out during the original design of the embankment appear to be due to change in geometry of the wall and change in fill material properties. The maximum height of the embankment was about 9.6 m. However, the original RE wall design called for 7.2 m of embankment height plus a surcharge that approximately translates to about additional 1 m of embankment height, that is, a total height of embankment of about 8.2 m. Because of the intended use of fly ash in embankment construction, in the original RE wall design, a unit weight of 16 kN/m³ was assumed for the fill material. Since the embankment behind the RE wall was ultimately constructed with river sand, the unit weight assumed during the original design turned out to be smaller than the actual.

Fig. 6 Results of limit equilibrium stability assessment of the RE wall

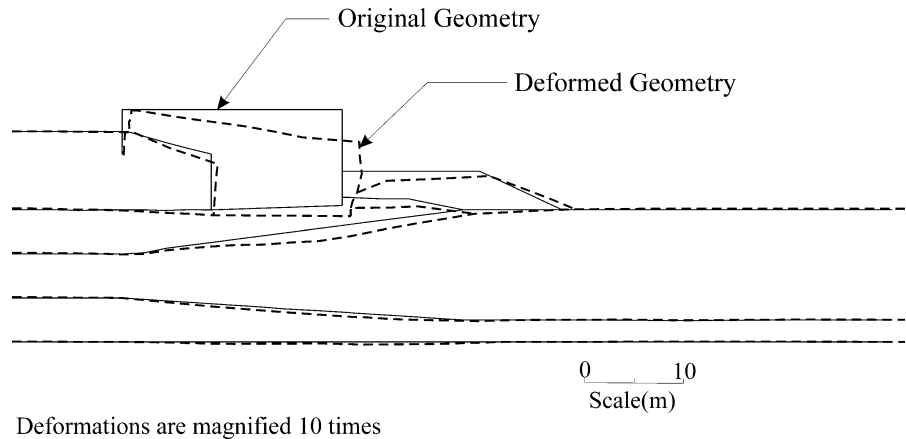
The finite element results at the end of construction in terms of deformations and velocity vectors are shown graphically in Figs. 8 and 9, respectively. The numerical analyses predict failure due to excessive deformations in the backfill soil adjacent to the retaining walls. The failure predicted by the numerical model is comparable with the failure observed in the reality. Table 3 compares deformations of the retaining walls predicted by the analysis with those observed in the actual field.

Fig. 8 Deformed geometry as obtained from the finite element analysis

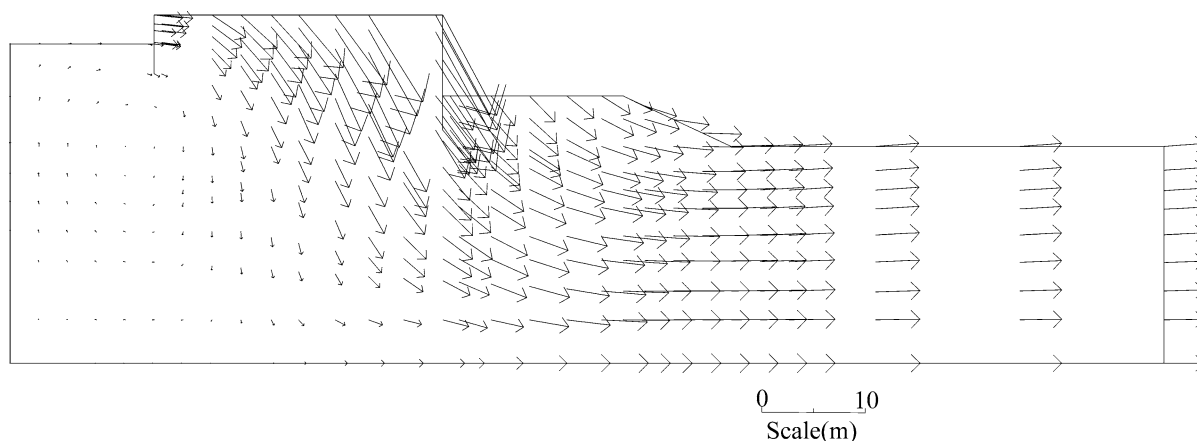
Fig. 9 Velocity vectors as computed in the finite element analysis

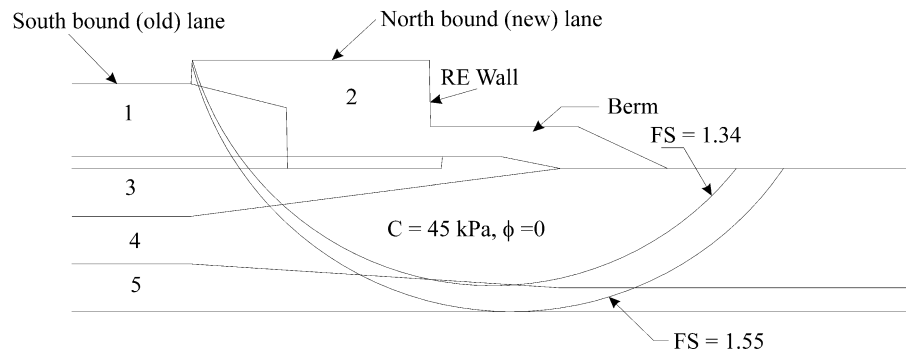
Fig. 10 Stability assessment of the RE wall with undrained strength of 45 kPa for foundation soil type 4

construction, availability of construction materials, etc., the last option is chosen. The numerical analyses are repeated to find out the required undrained strengths of the foundation soils to stabilize the RE walls. Figure 10 shows that based on limit equilibrium analyses, if the foundation soil type 4, has a minimum undrained strength of 45 kPa, (keeping strengths for all other soils same as before) the required minimum factor of safety of 1.2 shall be met for the embankment stability. Therefore attempts are made to drain and consolidate the soil types 4 and 5 under the road embankment with PVDs to achieve the above required minimum undrained strength. The method included installation of PVDs up to 13 m depth, construction of a two-stepped stabilizing berm along the outer face of the failed wall, and reconstruction of the RE wall and the highway embankment.

The PVDs (Colbondrain[®] CX 1000) were installed in October 2006 at 1.2 m horizontal spacing in a square grid pattern using a mandrel of diamond shaped cross section with diagonals measuring 50 and 120 mm. The width of the PVD treated zone was 19 m measured from the face of the failed wall. The stabilizing berm was constructed between October 2006 and February 2007. The height of the upper

bench was 3 m lower than the finished road grade and its width was 20 m. The maximum overall berm width measured from the base of the reconstructed RE wall to the toe of the lower bench was 37 m. After removing the failed embankment to an elevation of about 5.75 m above the original ground surface, reconstruction work for the RE wall was taken up in February 2007. Drilling, sampling and Standard Penetration Testing and field vane shear tests were conducted at the end of April 2007 to check whether the gain in undrained shear strength due to accelerated consolidation of soft soils within the PVD treated zone met the required value. Data from these tests, presented in Fig. 11 together with the undrained shear strengths from nearby locations measured immediately after failure, indicate that the increased undrained shear strengths, following accelerated consolidation of the soils within the PVD treated zone for the most part, exceeded those assumed in the overall stability assessment for the embankment redesign. Embankment reconstruction above 8 m height was allowed from May 2007 after these data were reviewed. Fill placement for the remaining height continued thereafter and paving work was completed by the beginning of June 2007. The reconstructed

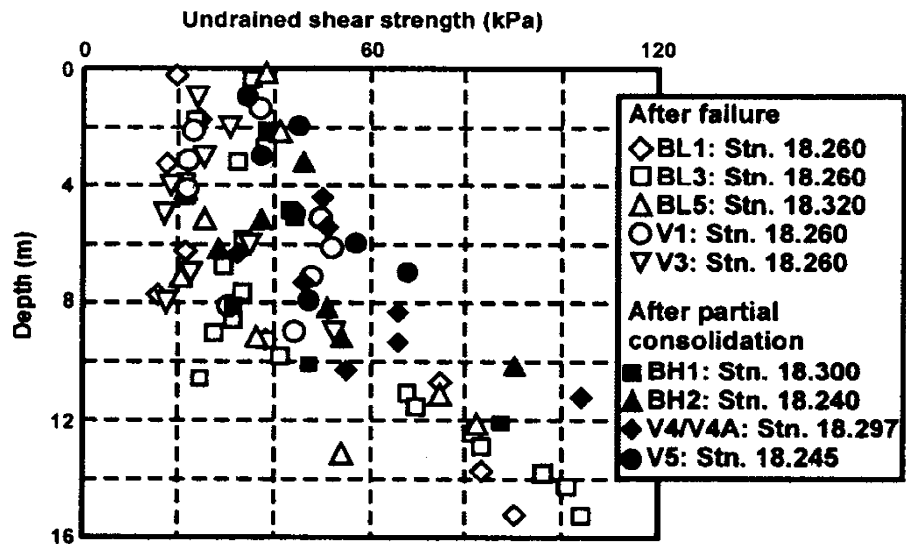
Fig. 11 Consolidation related increase in undrained shear strength after installation of PVDs
