## Study of a railway embankment reinforced with jute tassels

**Abstract.** This paper presents the results of laboratory model tests and corresponding numerical analyses carried out on a model slope representing an actual railway embankment which failed on several occasions after overnight heavy rainfall. In the absence of any field data, the displacement behaviour and failure pattern of the model embankment slope are observed in the laboratory under fully saturated condition and under a static load at the crest simulating the actual rail loads. A study is also performed by reinforcing the slope with thin jute tassels of 1 mm diameter. The numerical simulation of the model tests is performed by a commercial program called FLAC. The responses of the model slope with and without jute tassels are observed in fully saturated condition. Significant improvement in deformation of the slope is observed both in the case of numerical analyses and laboratory experiments when jute tassels are utilized as a slope protection measure. The study indicates that the stability of the railway embankment can be improved significantly at low cost by reinforcing it with jute tassels.

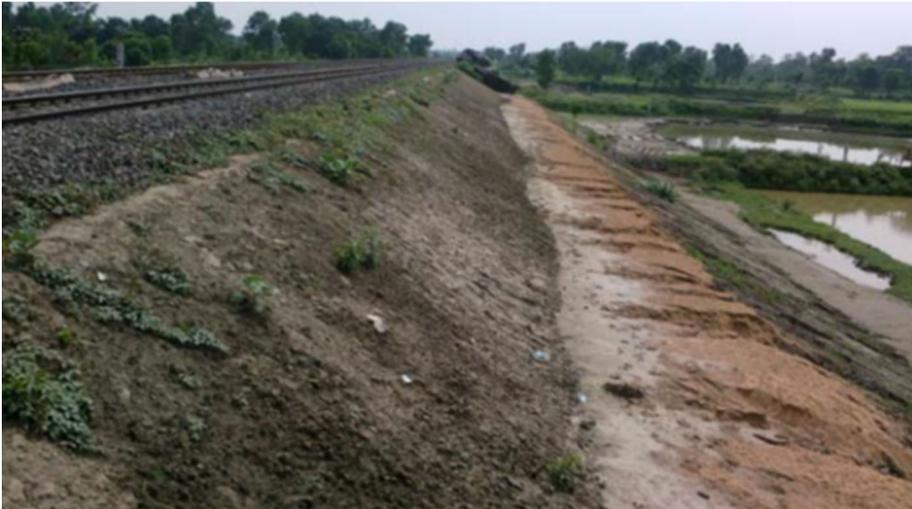
(a)

**Figure 1.** (a). Railway embankment at the accident site in Malda, India. (b). Gully formation on the embankment slope due to seepage of rain water.

The repeated failure of the railway embankment at a place called Malda in the state of West Bengal in India is the main focus of the present study. Figure 1a shows a cross section of the railway embankment. At least three major train accidents have occurred in the recent past causing loss of property and human life at this place. In all the cases, the accidents occurred after overnight continuous heavy rainfall. The investigating agencies have blamed them on the sudden subsidence of the embankment due to pore water pressure buildup within the embankment and its foundation (RDSO 1998, 2011). The site inspection in August 2012 by the authors revealed several gullies and wet areas on the slope of the embankment formed by the seepage of the rainwater. Figure 1b shows one such rain water gully on the slope at the accident site. Considering the destructiveness of these sudden slope failures, it is decided to perform geo-mechanical modelling of the slope failure mechanisms occurring within the embankment to assess the effect of rainfall on the embankment and to estimate the hazard due to sudden subsidence. This kind of slope failure after prolonged and/or heavy rainfall is not very uncommon throughout the world and several cases have been reported in the literature (Fowze *et al* 2012; Au 1998; Fourie 1996). But only a very few solutions have been proposed at present on the topic. In the present case, based on Bishop's limit equilibrium method as well as finite element analyses, a 2 m wide rockfill stabilizing berm on the downstream slope and sheet pile cutoff wall near the toe of the embankment, as shown schematically in figure 2, is proposed as a possible mitigation measure. This remedial measure has been implemented at the places of past accidents but not throughout the whole susceptible area due to exorbitant cost associated with it and/or lack of fund. This has prompted a fresh look at a cheaper but effective alternative remedial measure to prevent embankment slope failures in saturated condition, like reinforcing the slopes with jute tassels which can be obtained from the paddy fields located on both sides of the railway tracks at Malda.

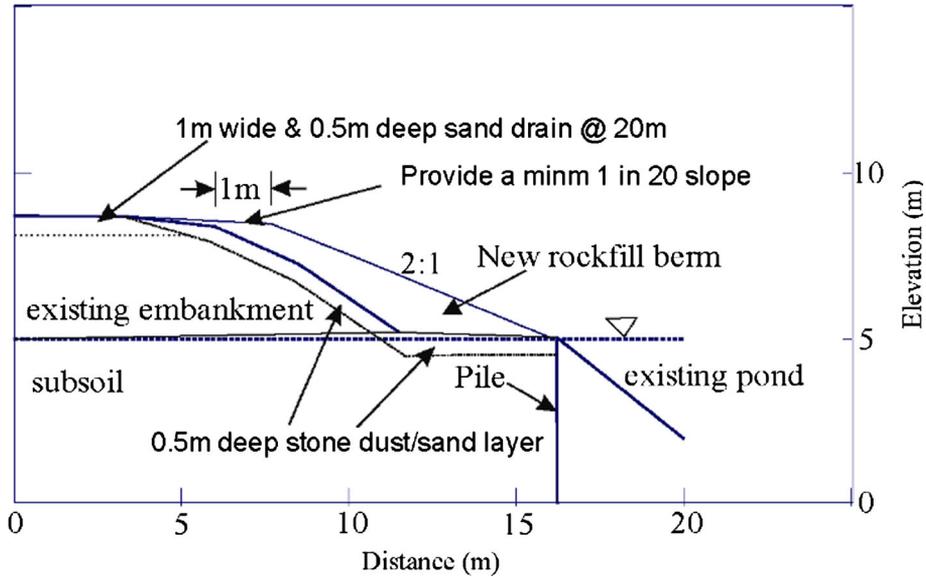
Figure 2. Mitigation measures recommended for the railway embankment at Malda.

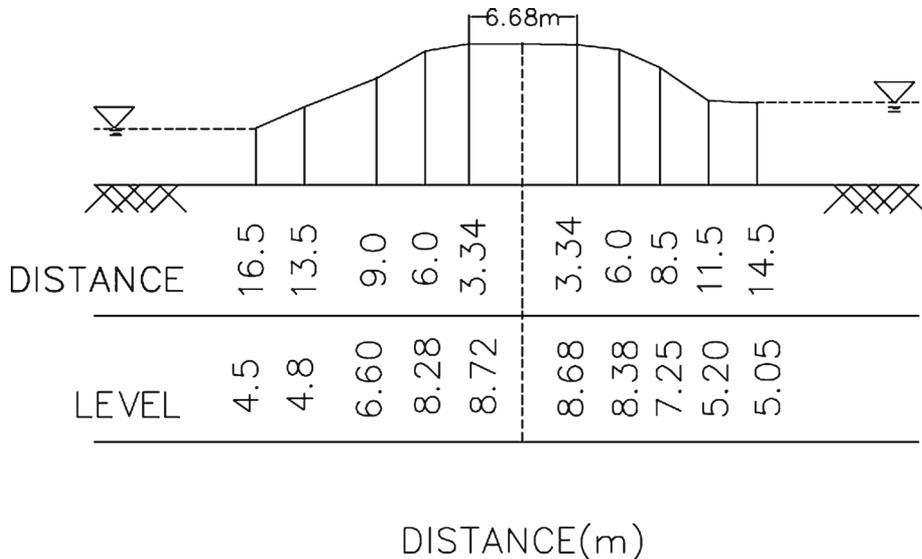
Figure 3. Geometry of the railway embankment at the accident site in Malda, India.

The surveyed profile of a typical cross-section of the embankment at Malda, which is chosen for this study, is shown in figure 3. The maximum height of the embankment is 4.4 m. The average side slopes of the embankment are 2(H):1(V). The average width of the crest is 6.7 m. At several locations, shallow ponds exist about 1.5 to 2 m from the toe on both sides of the embankment.

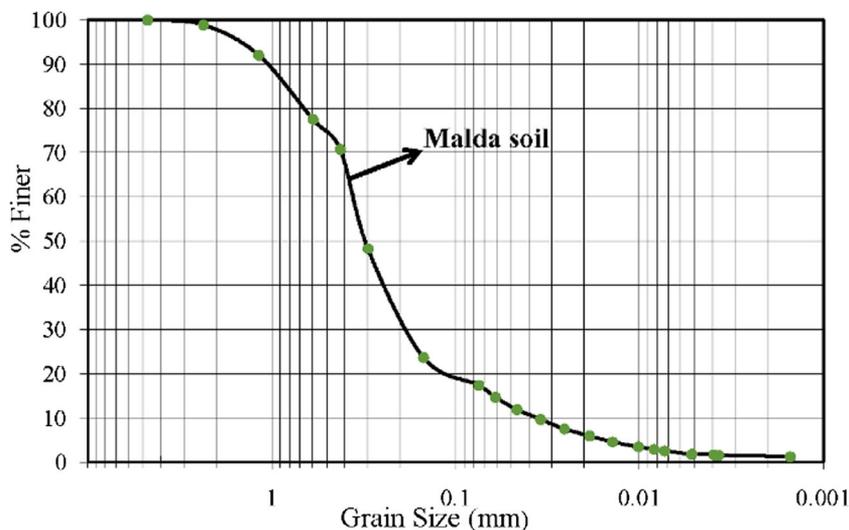
Figure 4. Grain size distribution of Malda soil.

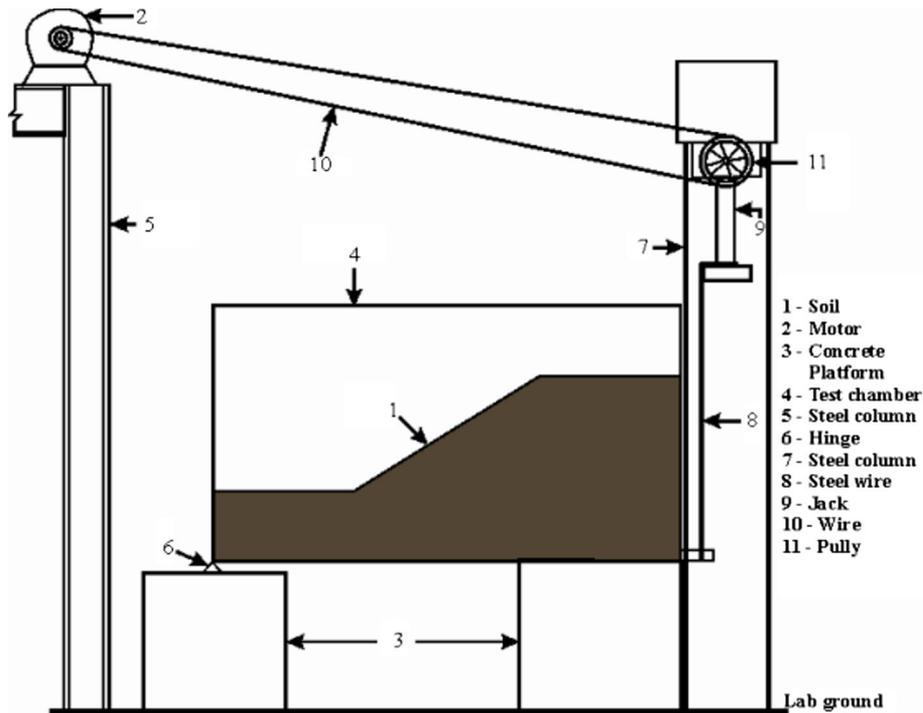
Figure 5. Test set-up for model test.

A test set-up has been prepared to conduct the model tests in the laboratory. Figure 5 shows the schematic diagram of the model test set-up. The main components of the test set-up are a test chamber made of plexiglass, a motorized jack and a supporting steel frame. The test chamber, having inside dimensions of 1.0 × 0.7 m in plan and a height of 0.13 m at front side and 0.60 m at the other three sides, is supported directly on two concrete platforms. The plexiglass walls have a thickness of 16 mm. All the joints are glued as well as reinforced with steel angles and the box may be considered to be rigid. The front side of the test chamber is attached to the bottom platform by two steel hinges so that the test chamber can rotate about these hinges. The backside side of the box is attached to a motorized jack with a steel wire. The jack moves up and down with the help of a motorized pulley and rotates the test chamber with the model slope in it. Before the model tests, all the plexiglass boundaries are lightly greased beforehand to eliminate friction at the boundaries as far as possible. During the test, the entire test chamber with the model embankment within it, is rotated from the initial horizontal position until the slope fails

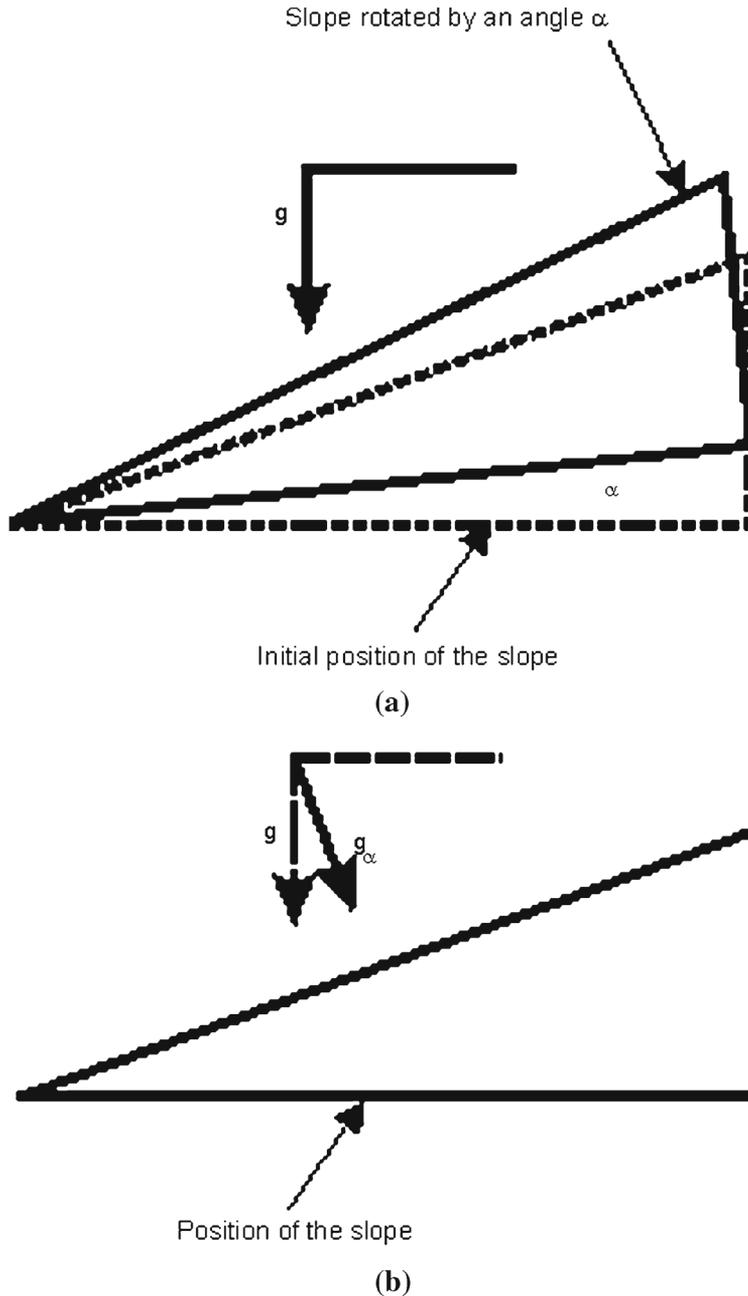
**Figure 6.** Schematic diagram of (a) Test procedure, (b) Procedure for numerical analyses.

or up to maximum  $16^\circ$ . Figure 6a shows the test procedure schematically. This procedure allows one to observe the embankment slope failure by increasing the slope angle effectively without reconstructing the embankment slope and in line with test procedures similar to those reported by Hsu *et al* (2014) and Schneider *et al* (2011).

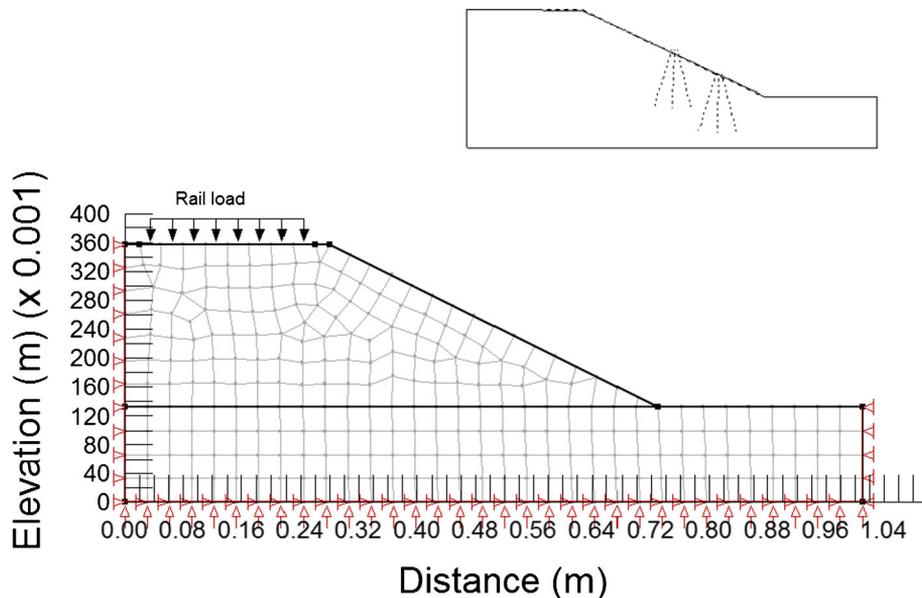
**Figure 7.** Geometry and numerical discretization of the embankment (Position of the cable elements representing jute reinforcements are shown in the inset).

The embankment and the foundation soil are modelled as a Mohr–Coulomb materials. All the soil parameters (table 1) are obtained from the laboratory tests of the Malda soil collected from the field and specified for the numerical model. The jute reinforcements are modelled as cable elements. The cable elements are one-dimensional axial elements. The cables can yield in tension or compression, but they cannot sustain a bending moment. The FLAC program utilized in this study is two-dimensional; the three-dimensional effect of regularly spaced elements (cables) is accommodated by scaling their material properties in the out-of-plane direction. Some of the properties of the jute reinforcements are obtained from the literature and some from the laboratory tests and are given in table 2. Figure 7 shows the dimensions and the numerical discretization of the embankment. The cable elements representing the jute reinforcements are shown in the inset of figure 7.

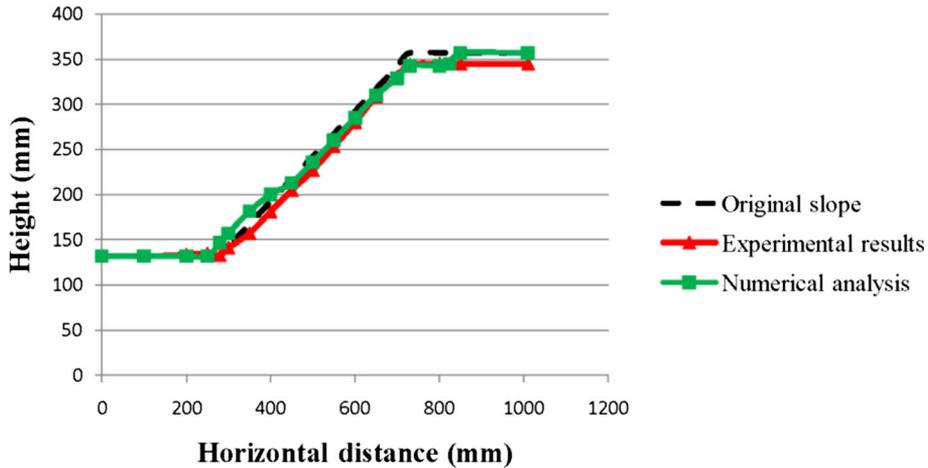
**Figure 8.** Comparison of test and numerical analysis of 2:1 Slope without reinforcement.

The results of the laboratory model tests and the numerical analyses of the model embankment with and without jute reinforcements are presented in terms of slope (surface) displacements and theoretical factor of safety. Table 4 compares the maximum displacements obtained from the laboratory model tests and the numerical analyses for the saturated embankment slope without any reinforcement. The maximum displacements obtained from the model tests and the numerical analyses are comparable for the first three effective slopes, that is, when the effective slopes are 2:1, 1.6:1 and 1.4:1. The deformations of the whole slope for the case of effective slopes of 2:1 and 1.4:1 as obtained from the model tests and the numerical analyses are shown in figures 8 and 9, respectively. For the case of 2:1 slope, the maximum deformation is observed at the outer edge of the crest. Though the maximum deformations are more or less same but the deformation pattern for the case of 1.4:1 slope is found to be quite different between the numerical analyses and the model tests. The model tests indicate the sliding of the slope surface while the numerical analyses show a settlement of the crest and a bulging at the toe. For the case of 1.4:1 slope, the experimental study shows maximum deformation at the outer edge of the crest while the numerical analyses show it at the toe of the slope. The discrepancy between the test results and the numerical results observed in figure 9 is arising due to the limitations of the numerical analyses in modelling a large flow problem.

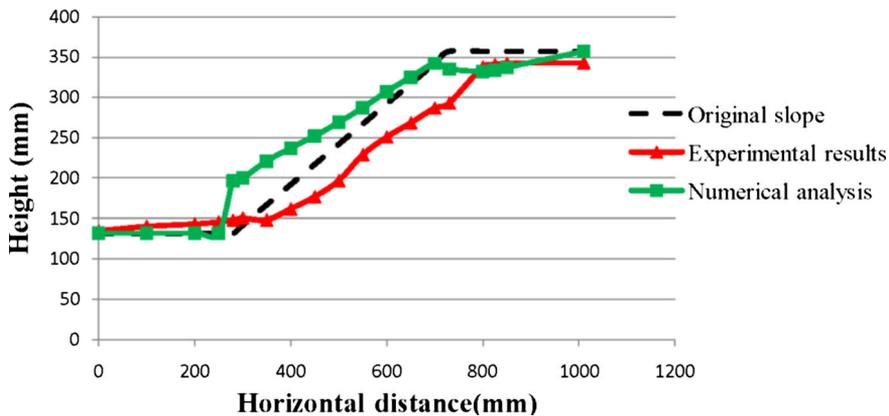
**Figure 9.** Comparison of test and numerical analysis of 1.4:1 slope without reinforcement.

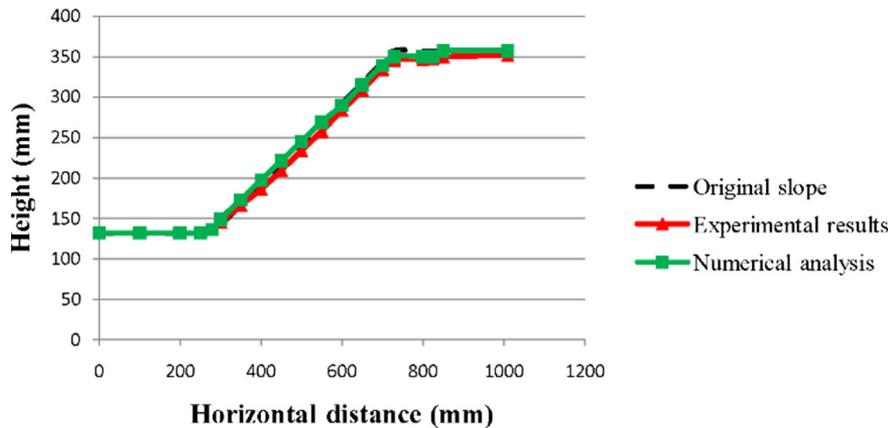
Figure 10. Comparison of test and numerical analysis of 2:1 slope with a single row of jute tassels.

from 15.68 by placing a single row of jute tassels. The maximum deformation reduces to 50.25 from 63.76 mm by placing a single row of jute tassels in 1.4:1 slope. These reductions in deformations are quite significant. The deformations of the whole slope obtained from the model tests and the numerical analyses are compared in figures 10 and 11 for the effective slopes of 2:1 and 1.4:1, respectively. As may be seen from figure 11, the numerical results show bulging of the toe contrary to the observations in the model test. This again may be due to the limitation of the numerical model in representing large debris flow problems. The model test indicates that there have been very little deformations of the slope between the place where a row of the jute tassel has been planted and the toe of the model embankment. The model tests show the effect of the placement of the jute tassels but the numerical analyses are not showing its effect that prominently. However, the numerical analyses also show significant reduction in deformations with the plantation of a single row of jute tassels. The maximum deformation reduces to 48.19 from 64.68 mm in the numerical analyses for the case of 1.4:1 effective slope.

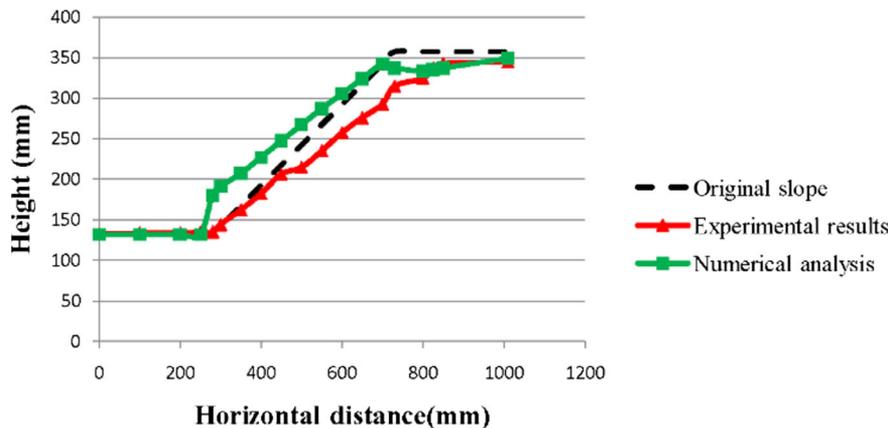
Figure 11. Comparison of test and numerical analysis of 1.4:1 slope with a single row of jute tassels.

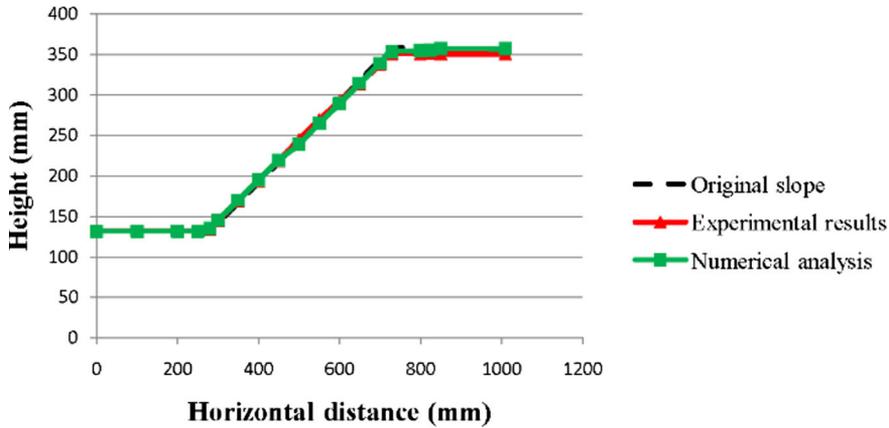
**Figure 12.** Comparison of test and numerical analysis of 2:1 slope with two rows of jute tassels.

numerical analyses are found to be comparable for all the cases. The results of model tests as well as numerical analyses predict further significant reduction in maximum deformations when compared to the cases with the unreinforced slope and slope with one row of jute tassels. For the 2:1 slope, the maximum deformation reduces to 6.5 from 15.68 mm by placing two rows of jute tassels on the slope. The maximum deformation reduces to 20.61 from 63.76 mm by placing two rows of jute tassels in 1.4:1 slope. These reductions in deformations are quite significant. The deformations of the whole slope obtained from the model tests and the numerical analyses for this case are compared in figures 12 and 13 for the effective slopes of 2:1 and 1.4:1, respectively. As may be seen from these figures, the bulging of the toe noticed in earlier numerical analyses is not present in this case. The test results show almost no deformation below the second row of the jute reinforcements. The experimental and numerical results are quite comparable. The maximum crest settlement in this case is found to be 6.5 mm by both numerical

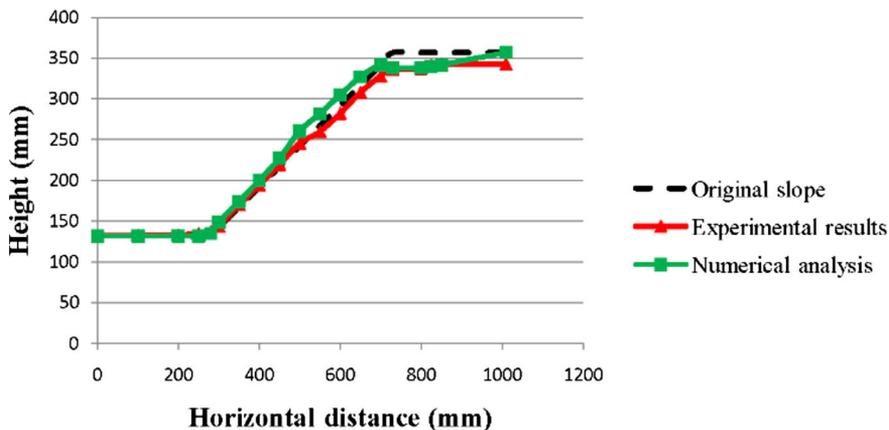
**Figure 13.** Comparison of test and numerical analysis of 1.4:1 slope with two rows of jute tassels.

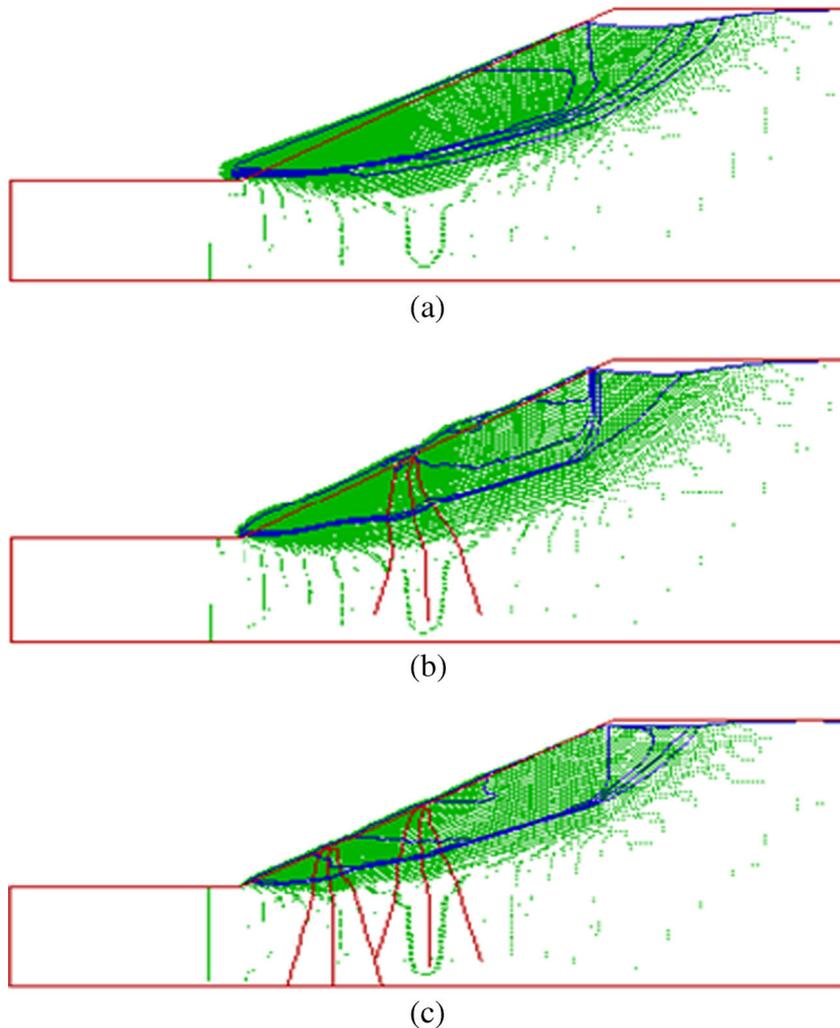
**Figure 14.** Comparison of the deformation of the 1.4:1 slope (a) without reinforcement, (b) with a single row of jute reinforcement, and (c) with two rows of jute reinforcements.

analyses and laboratory tests. This value is significantly less than 11mm obtained for the case with one row of jute reinforcements and 13 mm of crest settlement observed in the case of unreinforced model embankment. Figure 14 compares the numerical results (slope deformations) for the cases of 1.4:1 slope without any reinforcement, with a single row of jute reinforcement and with two rows of jute reinforcements. The results prove very convincingly that two rows of jute reinforcements on the slope can significantly reduce the slope settlement and deformations.
