Numerical Study of a Failure of a Reinforced Earth Retaining Wall

A. Sengupta

Abstract The case history of a failure of a RE wall has been presented. The wall failed immediately upon completion due to the overestimation of the strengths of the foundation clay layers and due to the underestimation of the self weight of the fill materials. A typical cross-section of the wall along with the stabilizing embankment and the foundation are modeled numerically by the limit equilibrium method and by a finite element method. The strengths of the foundation soils are determined by field tests done after the failure of the wall. Both the analyses predicted failure of the wall. The deformations predicted by the finite element method are found to be comparable to the observed field data. The numerical analyses further indicate that by consolidating a foundation clay layer to a minimum undrained strength of 45 kPa, the required factor of safety for the wall along with the road embankment can be achieved theoretically. Accordingly, prefabricated vertical drains are used to expedite the drainage and consolidation of the foundation clay layers. After the field tests confirm that the required minim

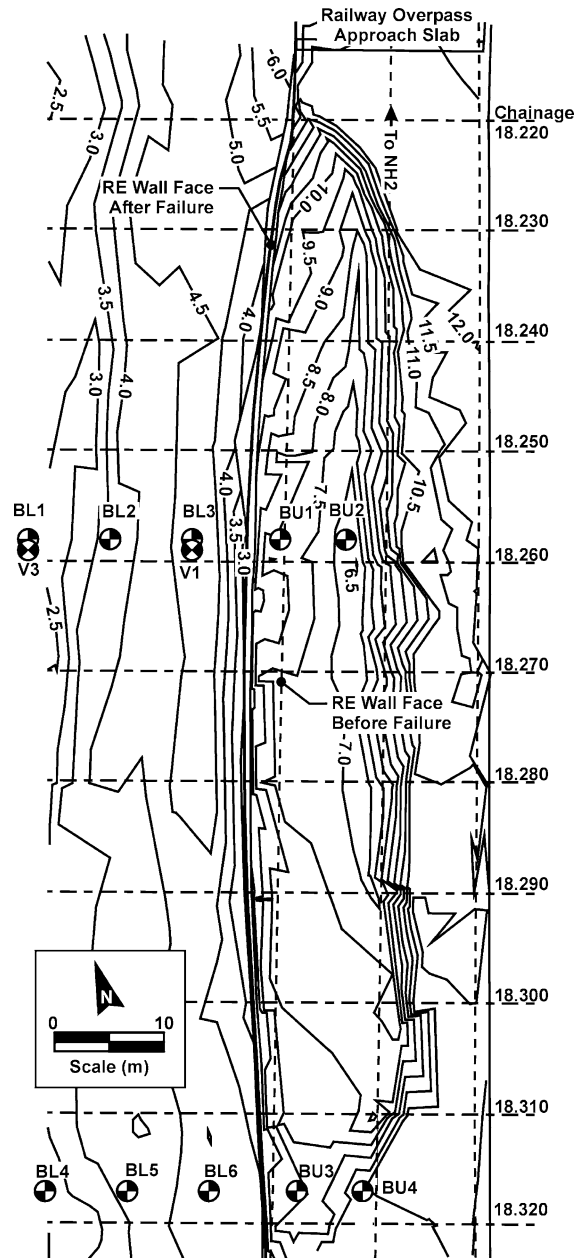
Fig. 3 Borehole locations

The subsurface investigation undertaken after the incident included drilling of fourteen boreholes for conducting in situ tests (standard penetration and field vane shear tests) and obtaining soil samples for laboratory tests. The laboratory tests included unconsolidated undrained (UU) triaxial tests and one-dimensional incrementally loaded consolidation tests besides grain size distribution, natural water content and Atterberg limit tests of selected tube samples. The boreholes BL1, BL2, BL3 were drilled at Chainage 18.258 km outside of the outer face of the failed segment of the RE wall. Field vane shear tests were conducted at locations V1 and V3 along this Chainage outside the area of the embankment. Within the embankment area at Chainage 18.258, the boreholes BU1 and BU2 were drilled. Similarly BL4, BL5 and BL6 were drilled at Chainage 18.317 km outside of the embankment area, while BU3 and BU4 were drilled at this Chainage within the embankment area. Locations of these boreholes are shown on Fig. 3 along with the results of the topographic survey undertaken immediately after the incident. Three additional boreholes, BU5, BU6 and BU7 were drilled outside the failed section at Chainage 18.350 km.

have been obtained from investigations conducted within or near the affected section of the embankment before the construction of the RE wall. Only two boreholes, BH5 and BH6, were drilled near the site prior to the construction of the RE wall. Four estimates of undrained shear strength obtained from the laboratory testing of samples extracted from these boreholes are of any relevance. These data, included in Fig. 4 for

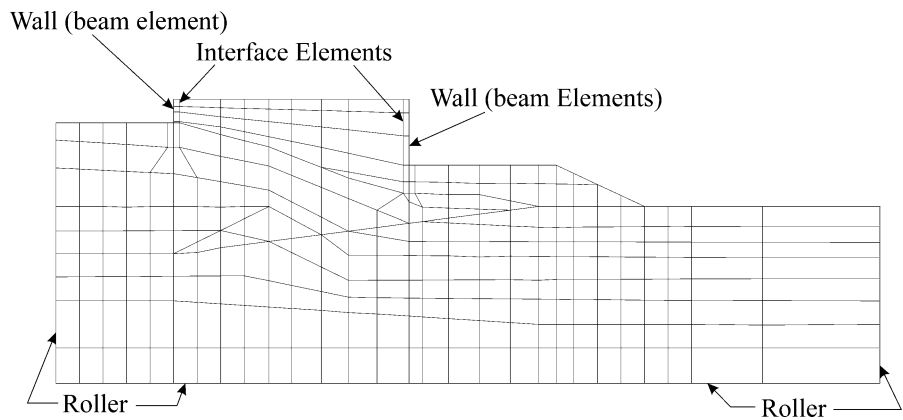
Fig. 8 Deformed geometry as obtained from the finite element analysis

The finite element results at the end of construction in terms of deformations and velocity vectors are shown graphically in Figs. 8 and 9, respectively. The numerical analyses predict failure due to excessive deformations in the backfill soil adjacent to the retaining walls. The failure predicted by the numerical model is comparable with the failure observed in the reality. Table 3 compares deformations of the retaining walls predicted by the analysis with those observed in the actual field.

The settlements and lateral shift of the roadway adjacent to the retaining wall obtained from the numerical analysis are comparable with those observed and recorded in the actual field. The minimum factor of safety for slope stability is found to be 0.51 for shallow surface near the retaining wall and 1.04 for a deep seated slip surface. The minimum factor of safety for the deep seated critical slip circle is found to be 0.983 by the limit equilibrium slope stability analysis.
